**Flood Control Project Maintenance
Levee Inspections****LMA District Cover Sheet****Spring 2011 Levee Inspection Results****San Joaquin County Flood Control and Water Conservation District**

Spring 2011 Levee Inspection Results

San Joaquin County Flood Control and Water Conservation District

Waterway			Bank	Unit Miles
Unit No. 01 Littlejohn Creek			Left	2.87

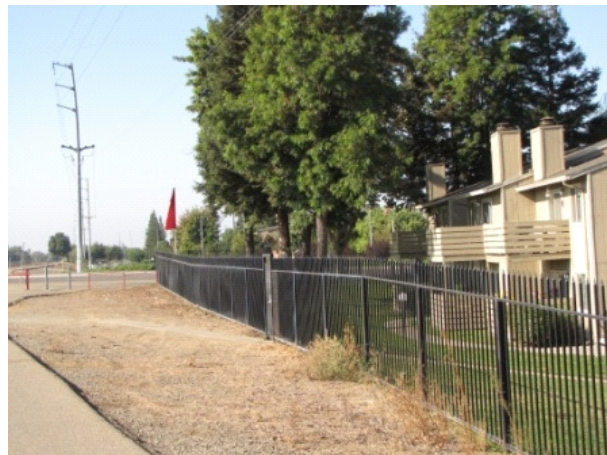
pkazi_s_20110328_273.jpg

Levee Mile Report Line	189
Start Levee Mile	21.73
End Levee Mile	21.77
Location	Land Side
Category	Earthen Levee
Item	Encroachments

View of fence along the landward shoulder looking downstream.

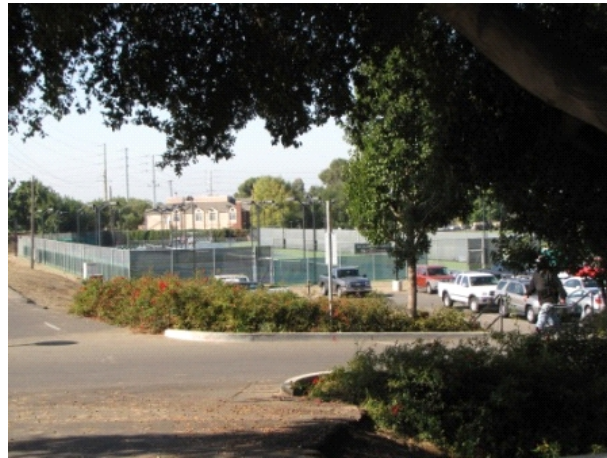
pkazi_s_20110328_274.jpg

View of landscaping maintained by UOP along the landward slope looking downstream.

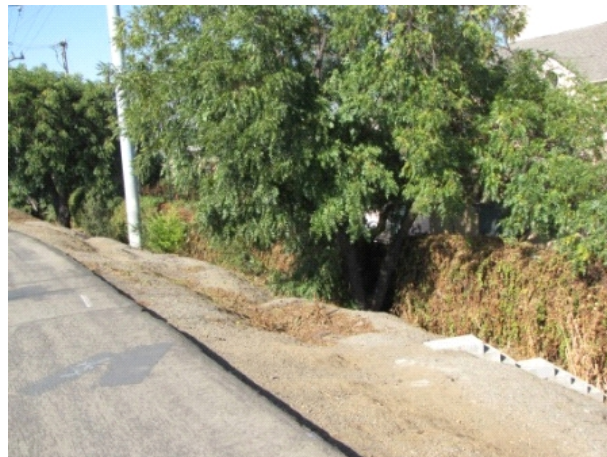
pkazi_s_20110328_210.jpg

View of landscaping along the landward toe of the levee looking downstream.

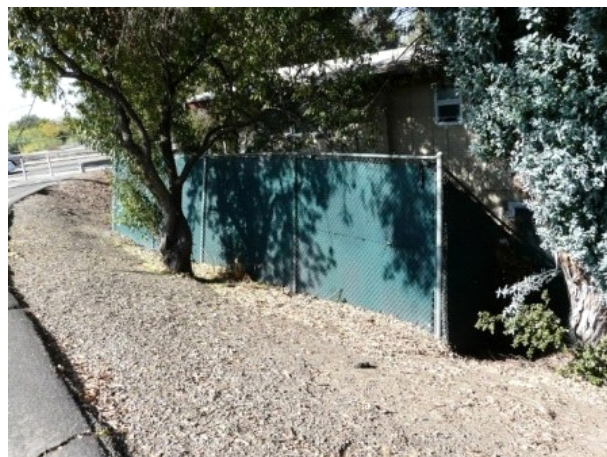
pkazi_s_20110328_233.JPG

Levee Mile Report Line	193
Start Levee Mile	22.36
End Levee Mile	22.37
Location	Land Side
Category	Earthen Levee
Item	Encroachments

Fence located from LM 22.36 to LM 22.37 significantly encroaches onto landside levee slope.

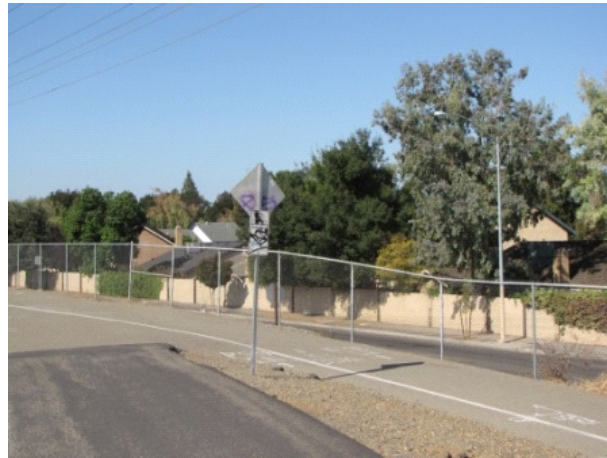
pkazi_s_20110328_275.jpg

View of fence along the landward shoulder looking downstream.

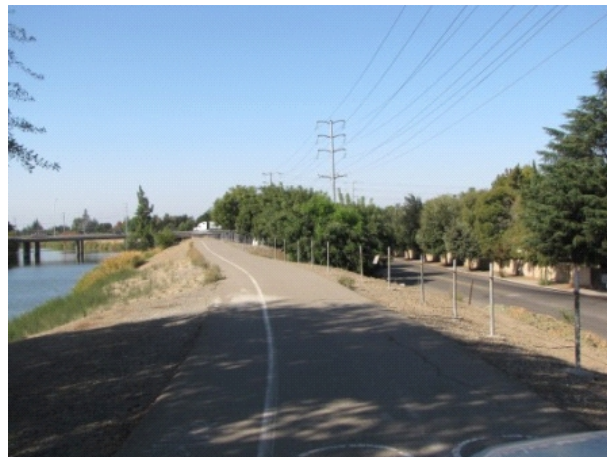
pkazi_s_20110328_276.jpg

Levee Mile Report Line	197
Start Levee Mile	23.54
End Levee Mile	23.69
Location	Land Side
Category	Earthen Levee
Item	Encroachments

View of fence along landward shoulder looking downstream.

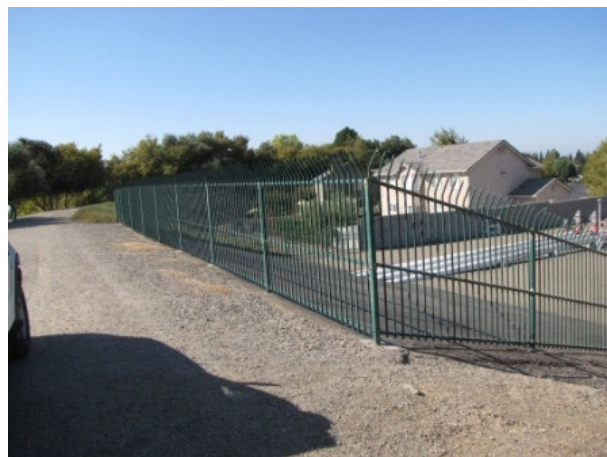
pkazi_s_20110328_277.jpg

Levee Mile Report Line	198
Start Levee Mile	24.20
End Levee Mile	24.21
Location	Land Side
Category	Earthen Levee
Item	Encroachments

View of fence along the landward shoulder looking downstream.

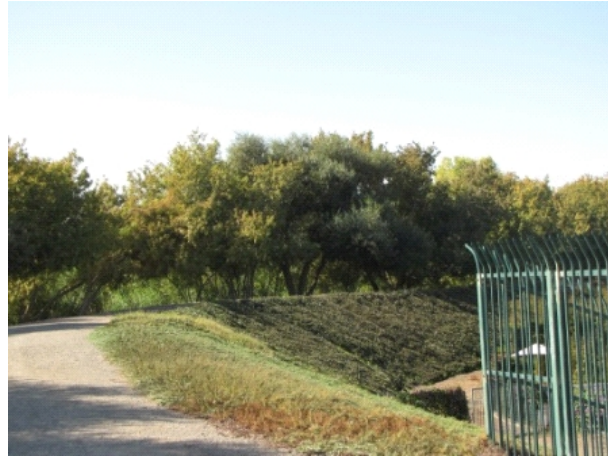
pkazi_s_20110328_211.jpg

View of typical landowner planted and maintained landscaping and irrigation along the landward shoulder, slope, and toe looking downstream.

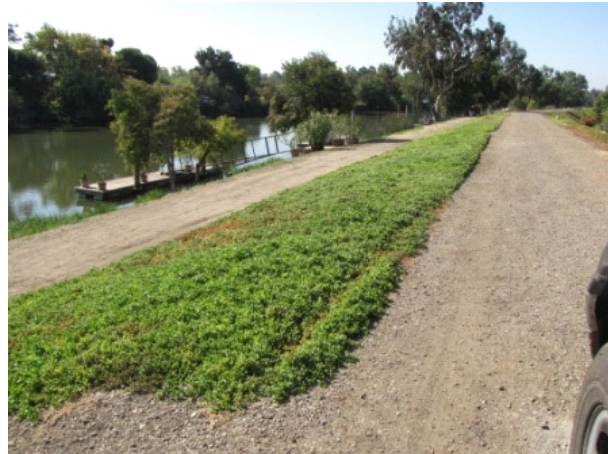
pkazi_s_20110328_278.jpg

Levee Mile Report Line	200
Start Levee Mile	24.65
End Levee Mile	25.59
Location	Water Side
Category	Earthen Levee
Item	Encroachments

View of typical landowner planted and maintained landscaping and irrigation along the waterward shoulder and slope looking downstream.

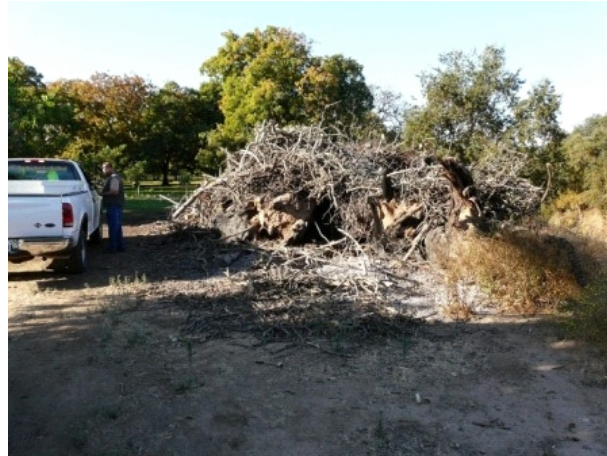
Levee Mile Report Line	2
Start Levee Mile	0.32
End Levee Mile	0.32
Location	Crown
Category	Earthen Levee
Item	Encroachments
<p>Prunings pile located at LM 0.32 on waterside shoulder of access road. The pile impedes access and forces vehicles to drive through orchard.</p>	
pkazi_s_20110328_285.JPG

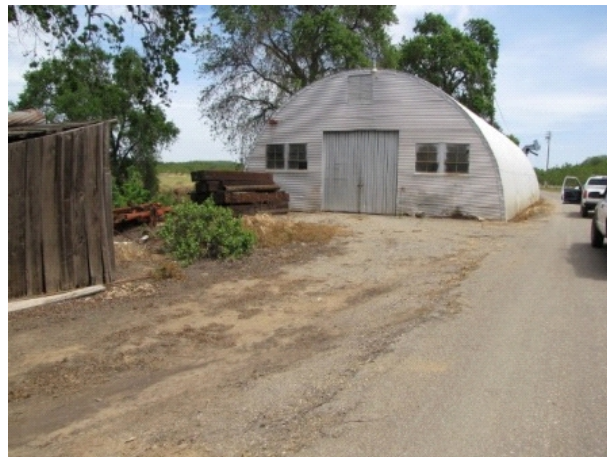
Levee Mile Report Line	3
Start Levee Mile	0.54
End Levee Mile	0.54
Location	Water Side
Category	Earthen Levee
Item	Encroachments
<p>Building/shed and other equipment located on waterward side of access road. There is no vehicle access adjacent to the channel.</p>	
pkazi_s_20110328_298.jpg

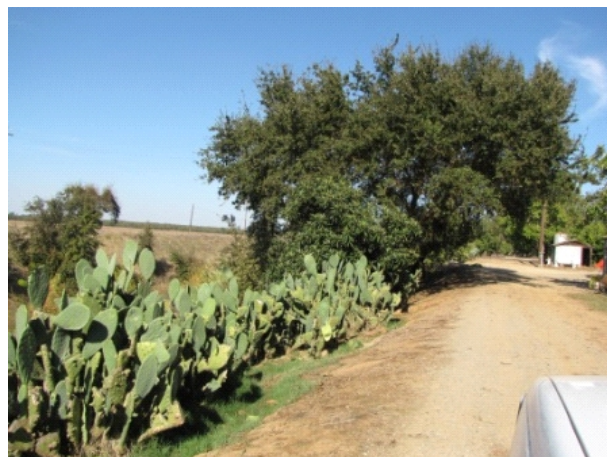
Levee Mile Report Line	8
Start Levee Mile	0.83
End Levee Mile	0.89
Location	Water Side
Category	Earthen Levee
Item	Encroachments
<p>View of landowner maintained landscaping on waterward side looking upstream.</p>	
pkazi_s_20110328_346.jpg

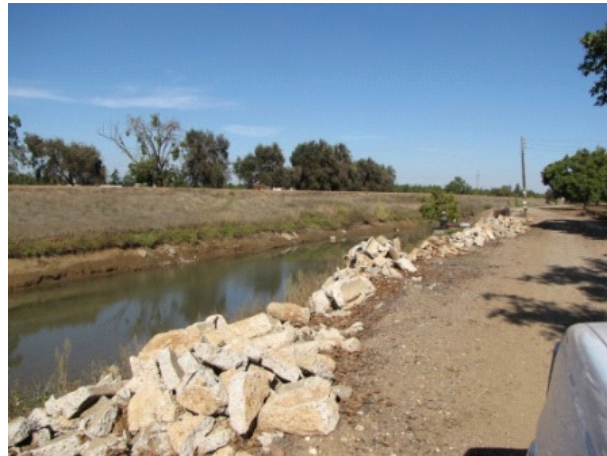
Levee Mile Report Line	16
Start Levee Mile	2.47
End Levee Mile	2.50
Location	Water Side
Category	Earthen Levee
Item	Encroachments
View of concrete debris on waterward side looking upstream.	
pkazi_s_20110328_345.jpg

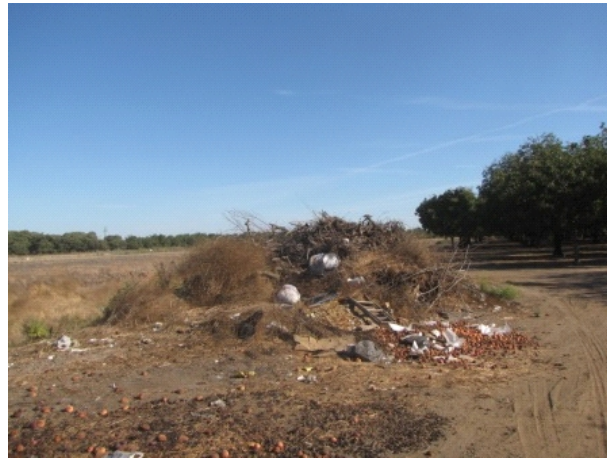
pkazi_s_20110328_287.jpg

Updated view as of October 2010 of the burn pile looking upstream.

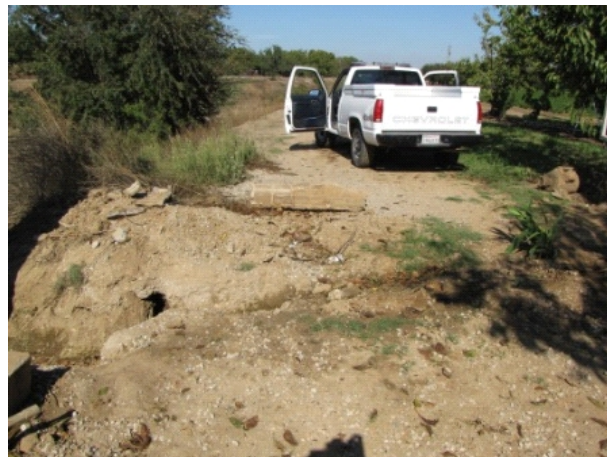
pkazi_s_20110328_344.jpg

Levee Mile Report Line	23
Start Levee Mile	4.31
End Levee Mile	4.31
Location	Crown
Category	Earthen Levee
Item	Crown Surface / Depressions / Rutting

View of recent construction that has left the access road damaged looking upstream.

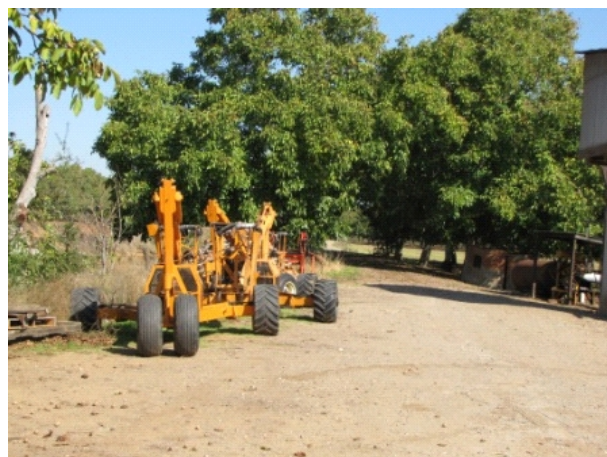
pkazi_s_20110328_341.jpg

Levee Mile Report Line	28
Start Levee Mile	5.94
End Levee Mile	5.94
Location	Water Side
Category	Earthen Levee
Item	Encroachments

View of equipment located on the waterward side looking upstream.

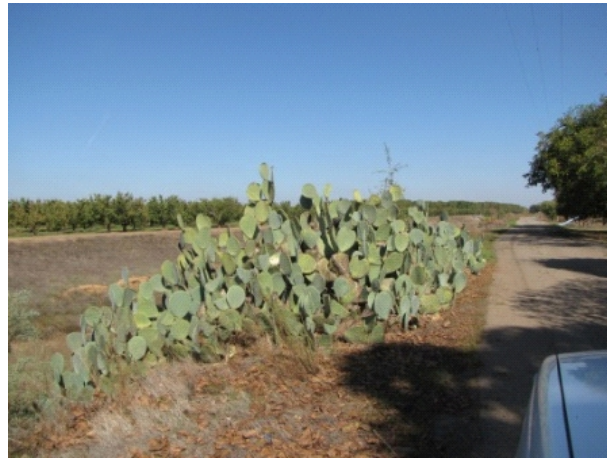
pkazi_s_20110328_340.jpg

View of cacti located on waterward side looking upstream.

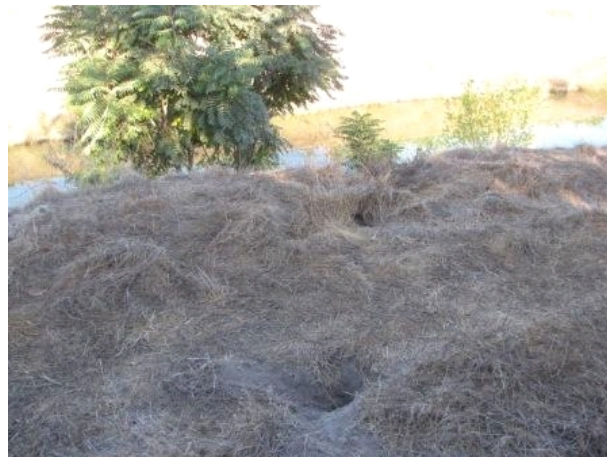
pkazi_s_20110328_283.jpg

Levee Mile Report Line	31
Start Levee Mile	6.19
End Levee Mile	6.19
Location	Water Side
Category	Earthen Levee
Item	Animal Control

View of rodent holes looking upstream.

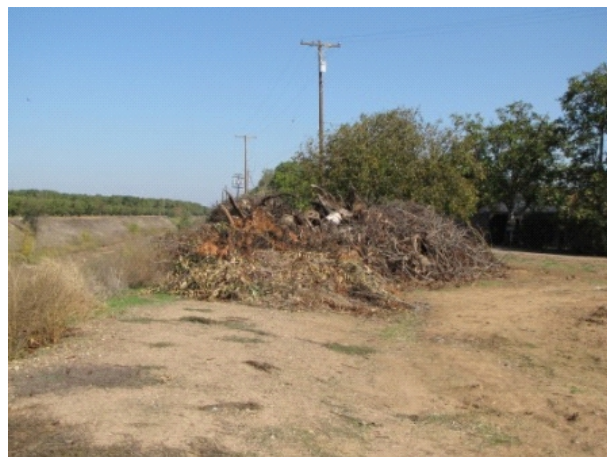
pkazi_s_20110328_288.jpg

Levee Mile Report Line	37
Start Levee Mile	6.32
End Levee Mile	6.32
Location	Water Side
Category	Earthen Levee
Item	Encroachments

View of a large prunings pile on waterward side and access road blocking visibility and access looking upstream.

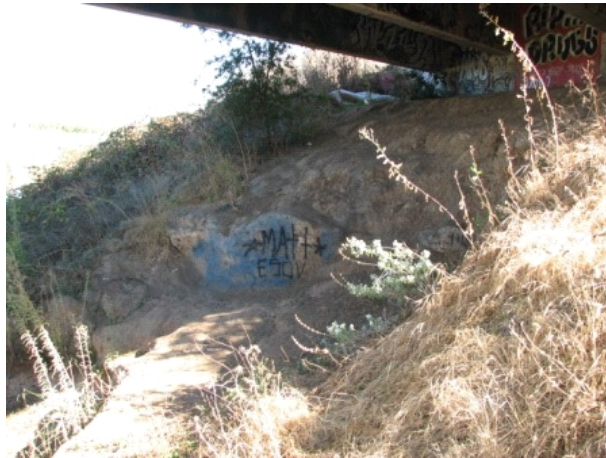
pkazi_s_20110328_279.jpg

Close up view of the erosion under the Milton Bridge, left bank.

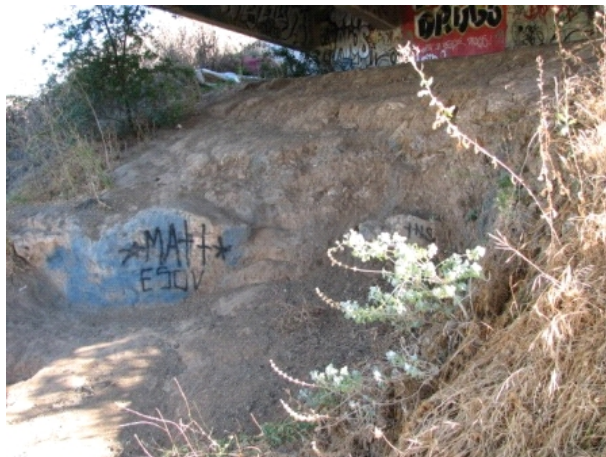
pkazi_s_20110328_280.jpg

Levee Mile Report Line	38
Start Levee Mile	6.47
End Levee Mile	6.48
Location	Water Side
Category	Supplemental
Item	DWR Erosion Survey

Close up view of the erosion pocket.

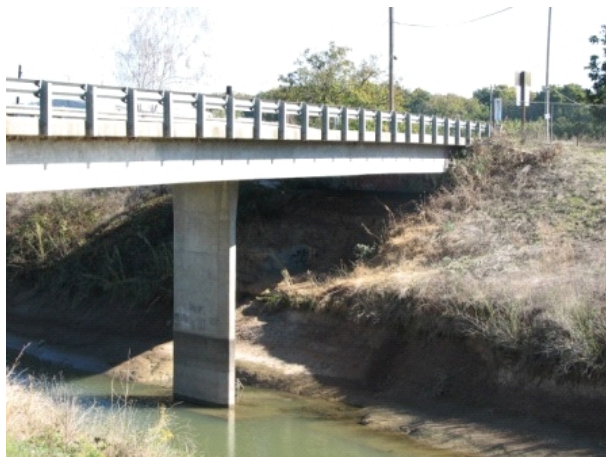
pkazi_s_20110328_281.jpg

Levee Mile Report Line	38
Start Levee Mile	6.47
End Levee Mile	6.48
Location	Water Side
Category	Supplemental
Item	DWR Erosion Survey

Upstream view of the bridge scour below the east end abutment of Milton Bridge.

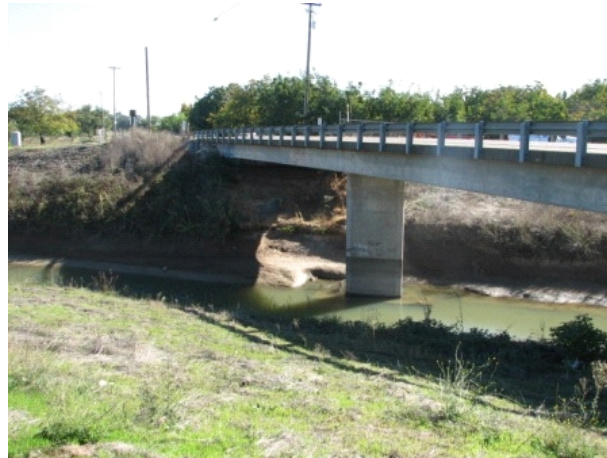
pkazi_s_20110328_282.jpg

Downstream view of the bridge scour.

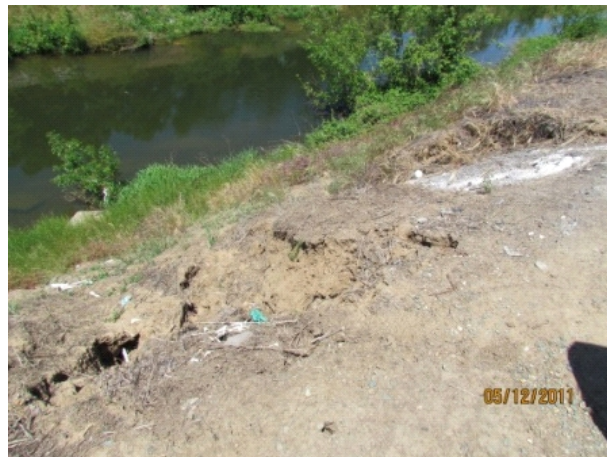
pkazi_s_20110526_603.jpg

Levee Mile Report Line	39
Start Levee Mile	6.97
End Levee Mile	6.97
Location	Water Side
Category	Earthen Levee
Item	Slope Stability

Slope stability was found on the shoulder of waterside of the levee. The picture was taken from the crown looking upstream.

39	6.97	6.97	Earthen Levee	Slope Stability	WS M	Repair slope instability.		37.981915 ° -121.093465 °	37.981915 ° -121.093465 °	200 Y
40	6.99	7.02	Earthen Levee	Encroachments	WS C	Landscaping		37.981746 ° -121.093754 °	37.981527 ° -121.094128 °	168
41	7.05	7.05	Earthen Levee	Encroachments	WS C	Landscaping		37.981349 ° -121.094625 °	37.981349 ° -121.094625 °	167
42	7.11	7.29	Earthen Levee	Encroachments	LS PO	Crops	Inspector Comments: Saplings located at toe of levee. Levee is slightly higher than the ground level at this location. Action has been started with the Board regarding these encroachments.	37.980849 ° -121.095438 °	37.979743 ° -121.098220 °	96 Y
43	7.30	7.30	Earthen Levee	Encroachments	WS M	Prunings	Inspector Comments: Burn pile has been burned but new material has been placed.	37.979522 ° -121.098305 °	37.979522 ° -121.098305 °	60
44	7.35	7.35	Earthen Levee	Animal Control	WS C	No rodents visible, but rodent burrows visible; need to backfill and compact or grout burrows.		37.979075 ° -121.099050 °	37.979075 ° -121.099050 °	95

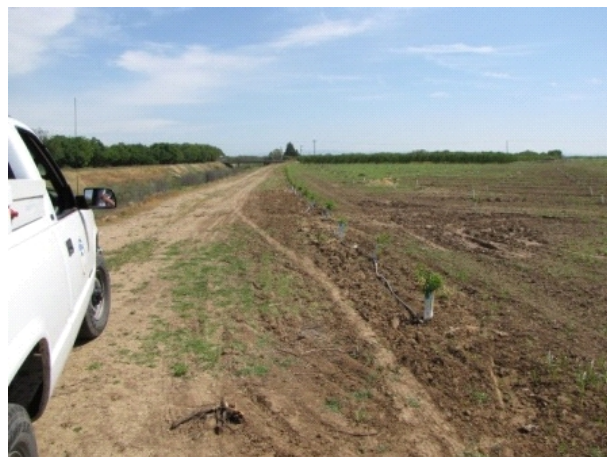
pkazi_s_20110328_297.jpg

Levee Mile Report Line	42
Start Levee Mile	7.11
End Levee Mile	7.29
Location	Land Side
Category	Earthen Levee
Item	Encroachments

Recently planted trees are within 10' of landward toe of levee. These trees are an encroachment and are potentially future maintenance issues.

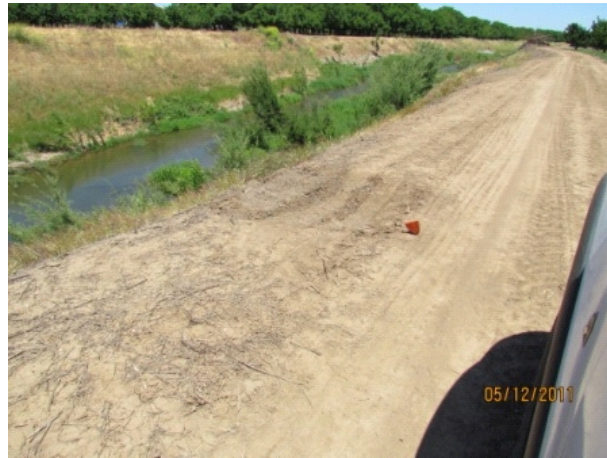
Levee Mile Report Line	48
Start Levee Mile	7.92
End Levee Mile	7.92
Location	Crown
Category	Earthen Levee
Item	Crown Surface / Depressions / Rutting
Depression on the crown of the levee near waterside shoulder. The picture was taken from the crown looking upstream.	
pkazi_s_20110526_602.jpg

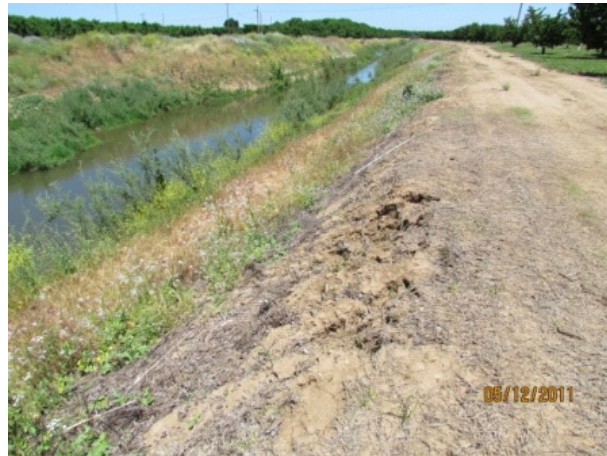
Levee Mile Report Line	49
Start Levee Mile	8.05
End Levee Mile	8.05
Location	Water Side
Category	Earthen Levee
Item	Slope Stability
Slope stability on the shoulder of the waterside of the levee. The picture was taken from the crown looking upstream.	
pkazi_s_20110526_601.jpg

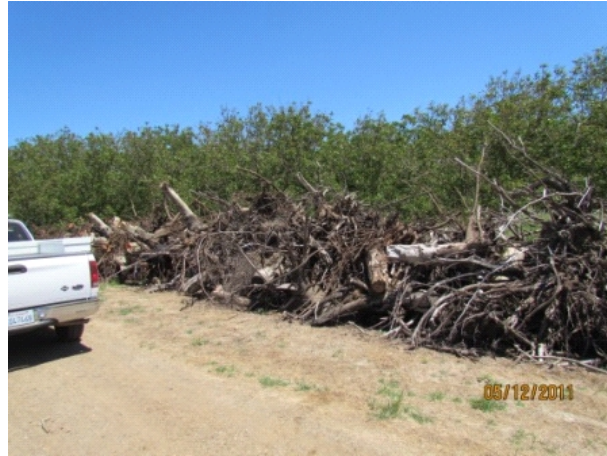
Levee Mile Report Line	52
Start Levee Mile	8.35
End Levee Mile	8.35
Location	Land Side
Category	Earthen Levee
Item	Encroachments
Pruning found on the landside of the levee looking upstream.	
pkazi_s_20110526_599.jpg

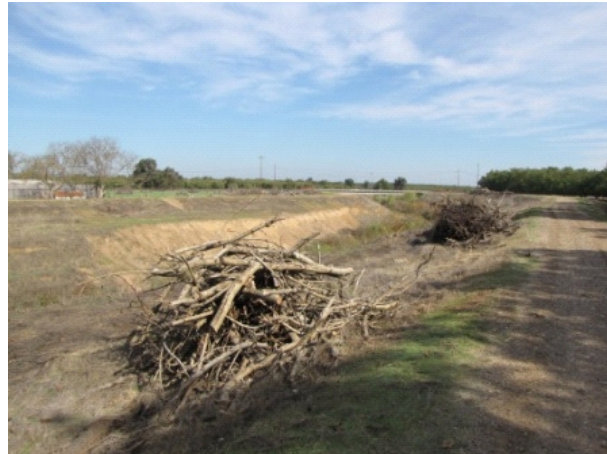
Levee Mile Report Line	54
Start Levee Mile	8.46
End Levee Mile	8.46
Location	Water Side
Category	Earthen Levee
Item	Encroachments
View of pruning piles located on waterward side looking upstream.	
pkazi_s_20110328_337.jpg

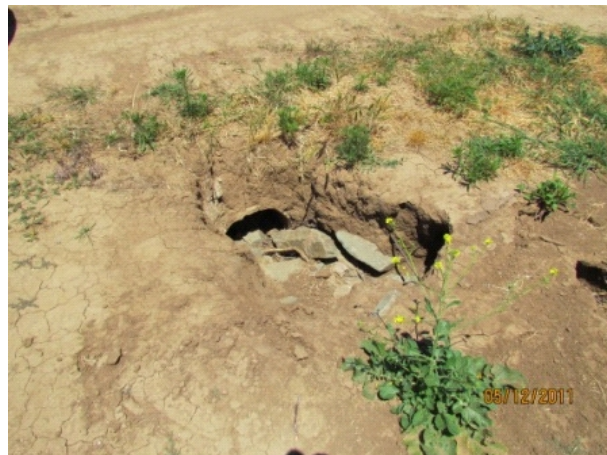
Levee Mile Report Line	58
Start Levee Mile	9.77
End Levee Mile	9.77
Location	Land Side
Category	Earthen Levee
Item	Encroachments
An abandon pipe was left by the farmer. The picture was taken from the toe of the landside of the levee looking upstream.	
pkazi_s_20110526_598.jpg

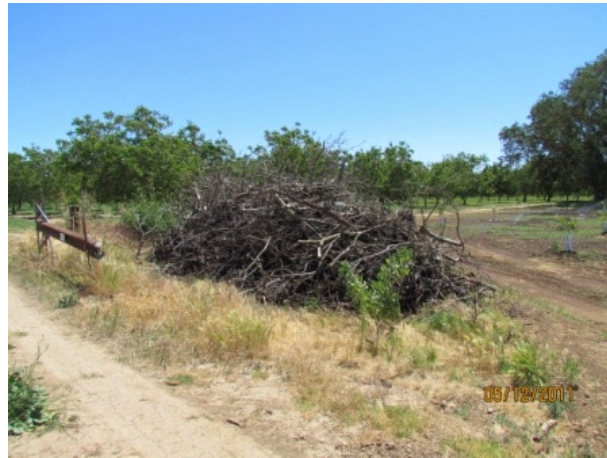
pkazi_s_20110526_597.jpg

Pruning was found landside of the levee. The picture was taken from the crown looking upstream.

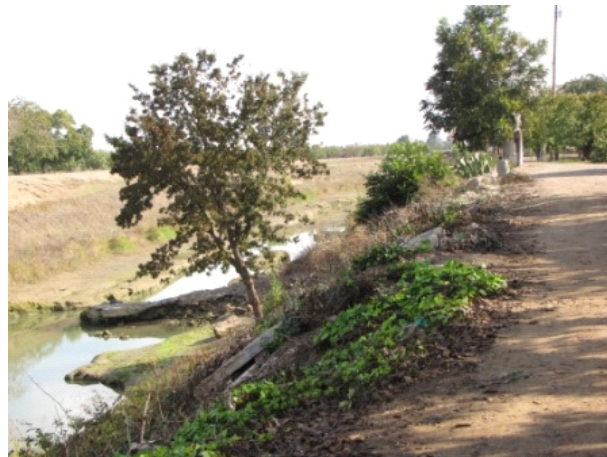
pkazi_s_20110328_335.jpg

Levee Mile Report Line	64
Start Levee Mile	10.84
End Levee Mile	10.88
Location	Water Side
Category	Earthen Levee
Item	Encroachments

View of landscaping on waterward side looking upstream.

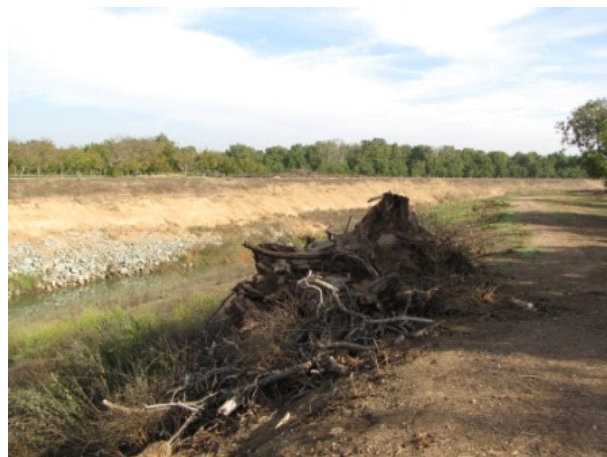
pkazi_s_20110328_296.jpg

Levee Mile Report Line	65
Start Levee Mile	11.07
End Levee Mile	11.07
Location	Water Side
Category	Earthen Levee
Item	Encroachments

View of prunings located on waterward side looking upstream.

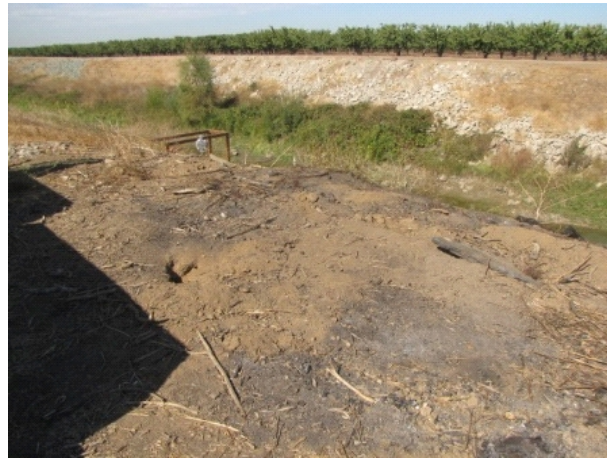
pkazi_s_20110328_291.jpg

View of rodent activity on the waterward shoulder looking downstream.

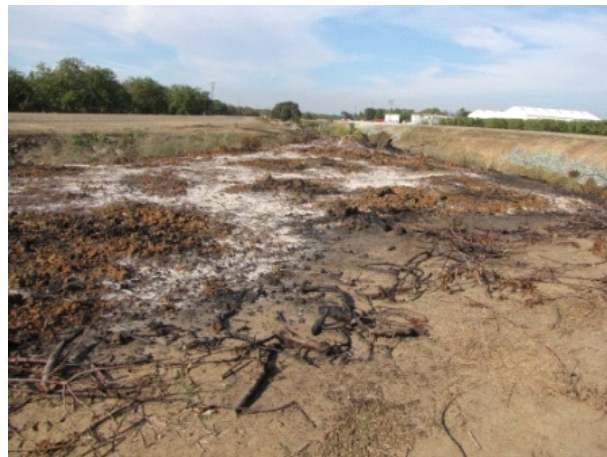
pkazi_s_20110328_295.jpg

Levee Mile Report Line	67
Start Levee Mile	11.41
End Levee Mile	11.41
Location	Water Side
Category	Earthen Levee
Item	Encroachments

View of location where prunings were burned on waterward side and access road looking downstream.

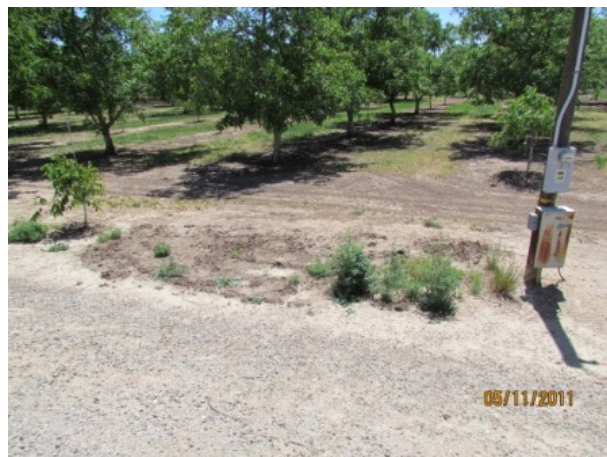
pkazi_s_20110523_596.jpg

Levee Mile Report Line	68
Start Levee Mile	11.51
End Levee Mile	11.51
Location	Land Side
Category	Earthen Levee
Item	Erosion / Bank Caving

The pit dug on previous inspection was filled and compacted. The picture was taken from the crown looking upstream.

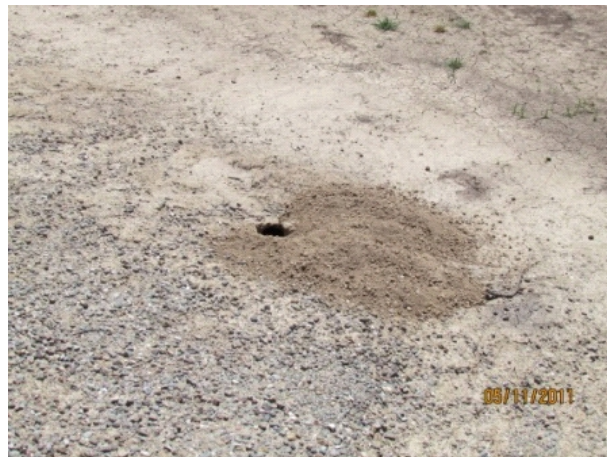
pkazi_s_20110523_595.jpg

Levee Mile Report Line	73
Start Levee Mile	11.83
End Levee Mile	11.83
Location	Land Side
Category	Earthen Levee
Item	Animal Control

A rodent hole was found on the landside of the levee looking upstream.

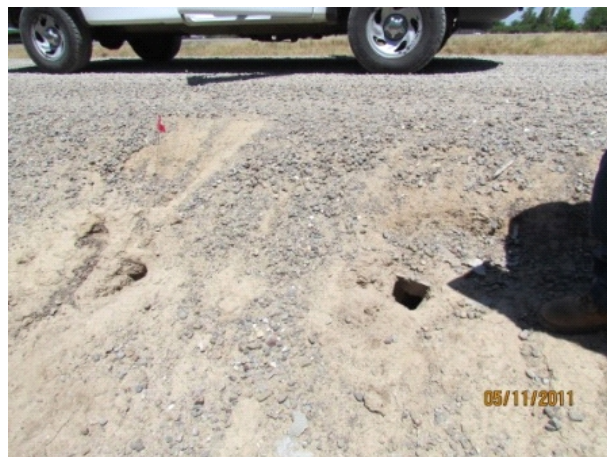
pkazi_s_20110523_594.jpg

Levee Mile Report Line	74
Start Levee Mile	11.92
End Levee Mile	11.92
Location	Land Side
Category	Earthen Levee
Item	Animal Control

Rodent holes were found on the landside slope of the levee. The picture was taken from the toe of landside of the levee.

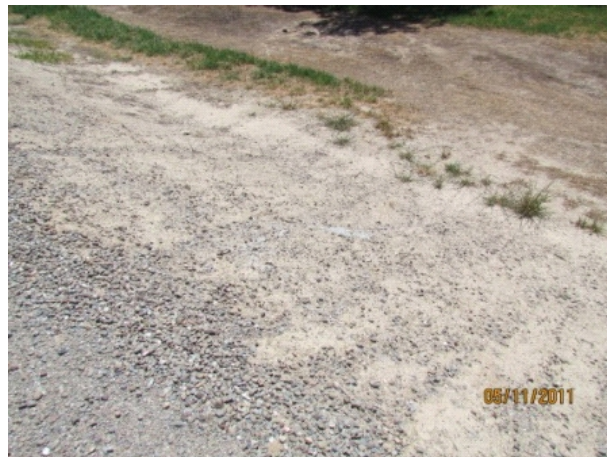
pkazi_s_20110523_593.jpg

Rodent hole was grouted by the LMA. The picture was taken from the crown looking upstream.

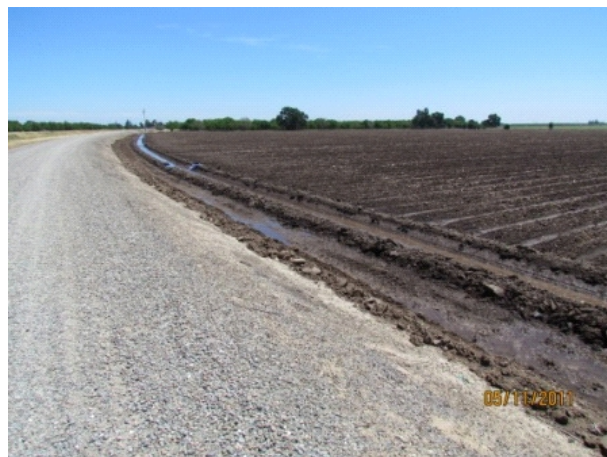
pkazi_s_20110523_591.jpg

Levee Mile Report Line	79
Start Levee Mile	12.27
End Levee Mile	12.47
Location	Land Side
Category	Earthen Levee
Item	Encroachments

An agricultural ditch was found on the landside of the levee. The picture was taken from crown looking upstream.

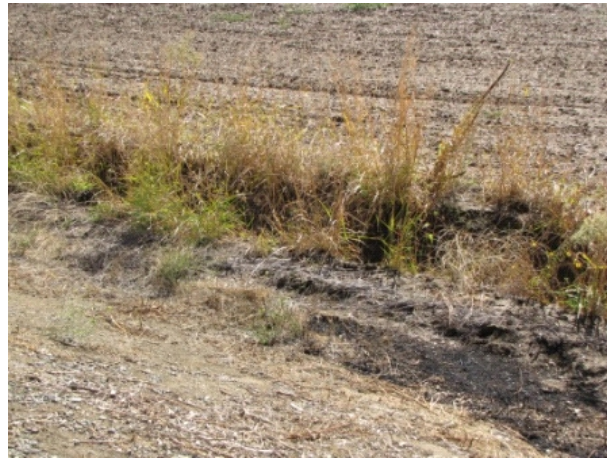
View of an irrigation/drainage ditch along the landward toe.

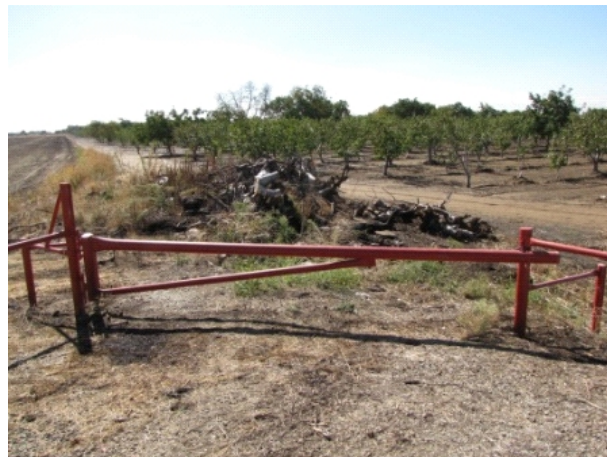
Levee Mile Report Line	84
Start Levee Mile	13.17
End Levee Mile	13.17
Location	Land Side
Category	Earthen Levee
Item	Encroachments

View of a prunings pile along the landward toe of an access ramp. Pile is blocking access through this gate.

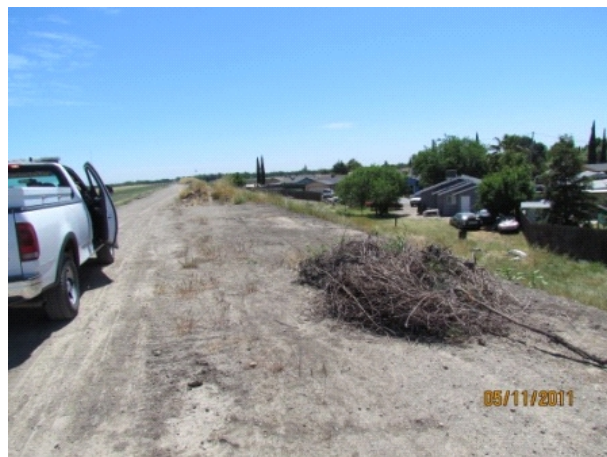
Levee Mile Report Line	86
Start Levee Mile	14.50
End Levee Mile	14.50
Location	Land Side
Category	Earthen Levee
Item	Encroachments

Pruning on the landside of the levee looking upstream.

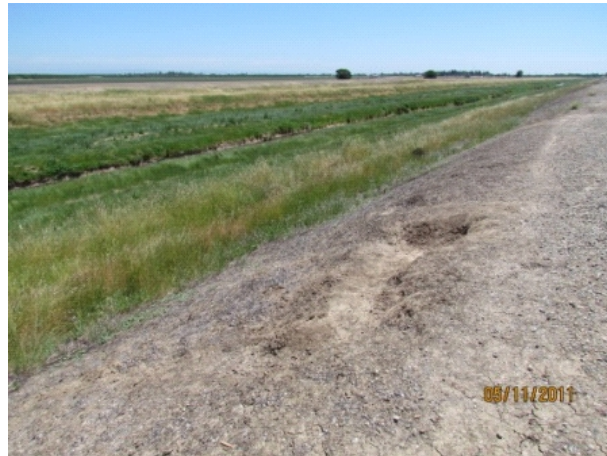
Slope stability on the waterside of the levee. The picture was taken from the crown looking upstream.

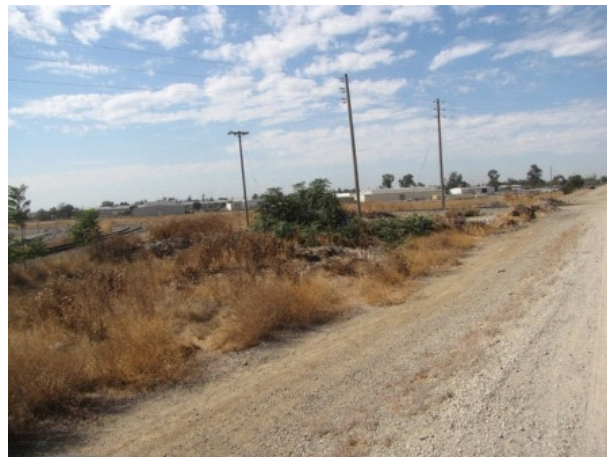
Levee Mile Report Line	88
Start Levee Mile	16.34
End Levee Mile	16.34
Location	Crown
Category	Earthen Levee
Item	Vegetation

View of vegetation within 10 feet of the landward slope looking downstream.

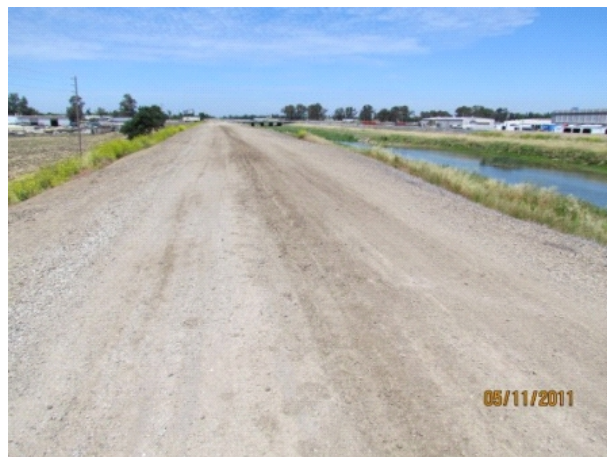
Levee Mile Report Line	90
Start Levee Mile	16.40
End Levee Mile	16.40
Location	Crown
Category	Earthen Levee
Item	Crown Surface / Depressions / Rutting

Rutting was found on the crown possibly due to vehicular traffic. The picture was taken from the crown looking downstream.

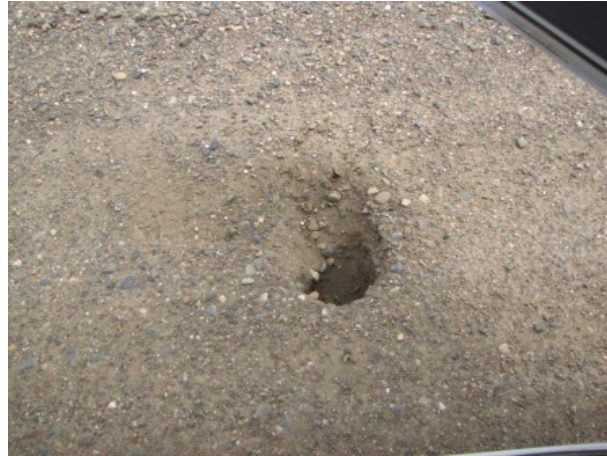
View of a depression in the crown of the levee.

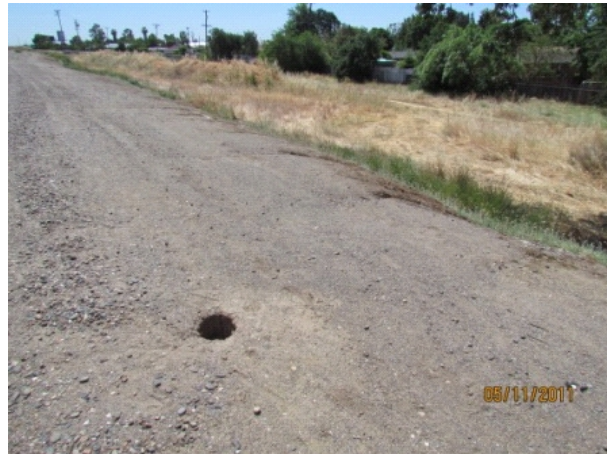
Levee Mile Report Line	93
Start Levee Mile	17.05
End Levee Mile	17.05
Location	Crown
Category	Earthen Levee
Item	Animal Control

A rodent hole was found on the crown of the levee. The picture was taken from the crown looking upstream.

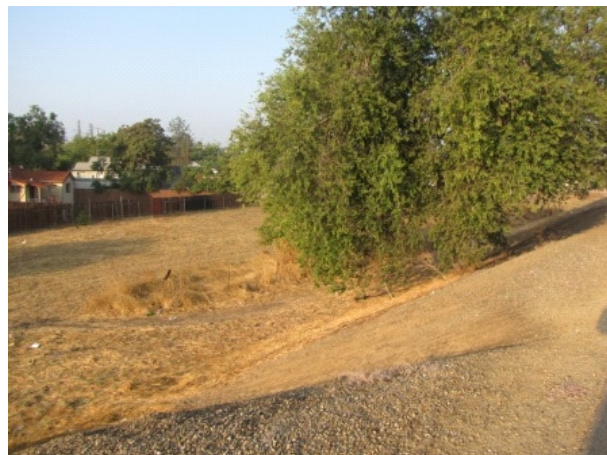
Levee Mile Report Line	94
Start Levee Mile	17.45
End Levee Mile	17.45
Location	Land Side
Category	Earthen Levee
Item	Slope Stability

View of damage to the landward slope caused by vehicular traffic looking downstream.

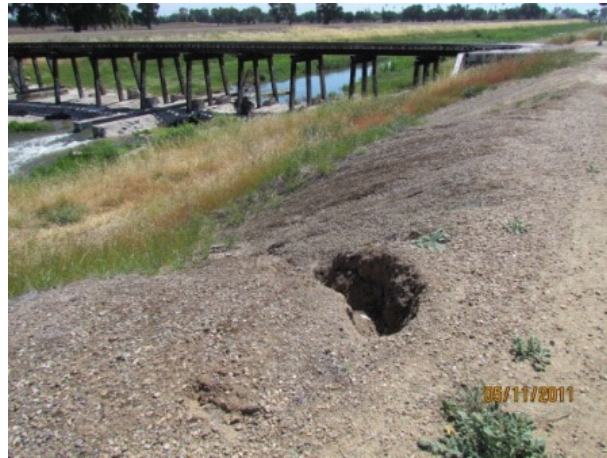
Slope stability caused by washout rodent holes on the waterside shoulder of the levee. The picture was taken from the crown looking upstream.

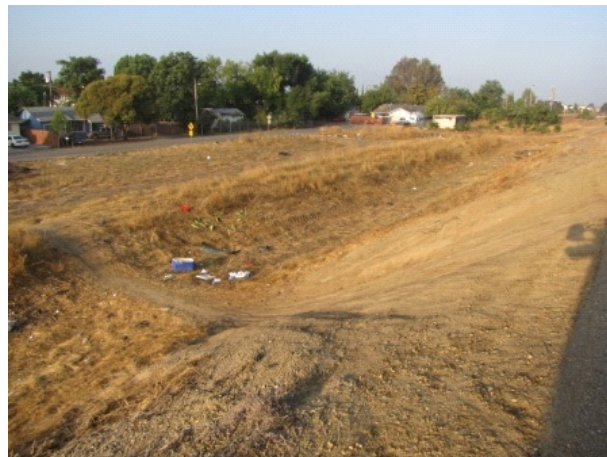
Levee Mile Report Line	98
Start Levee Mile	17.73
End Levee Mile	17.73
Location	Land Side
Category	Earthen Levee
Item	Slope Stability

View of damage to the landward slope caused by vehicular traffic looking downstream.

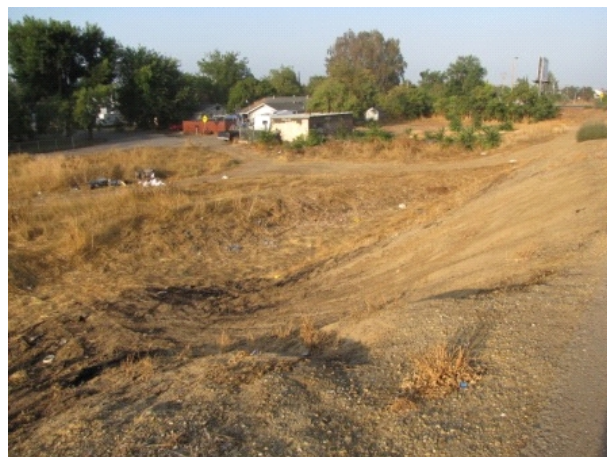
Levee Mile Report Line	99
Start Levee Mile	17.76
End Levee Mile	17.76
Location	Land Side
Category	Earthen Levee
Item	Slope Stability

View of damage on the landward slope caused by vehicular traffic looking downstream.

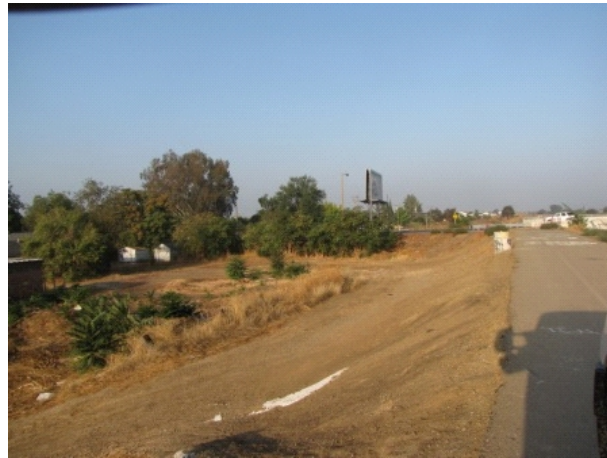
View of damage to the landward slope caused by vehicular traffic looking downstream.

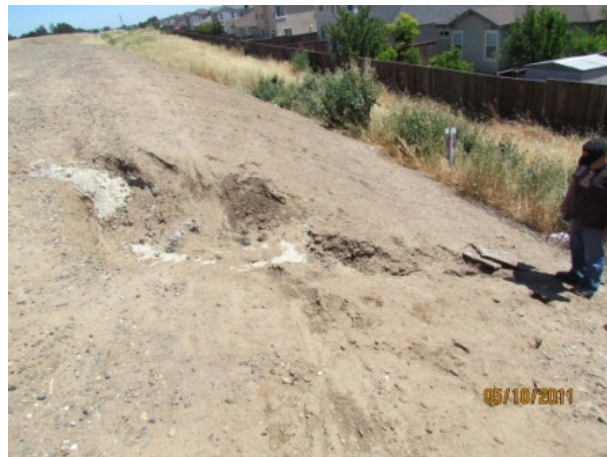
Levee Mile Report Line	102
Start Levee Mile	18.55
End Levee Mile	18.55
Location	Land Side
Category	Earthen Levee
Item	Slope Stability

Slope stability caused by rodent holes on the landside slope of the levee. The picture was taken from crown looking upstream.

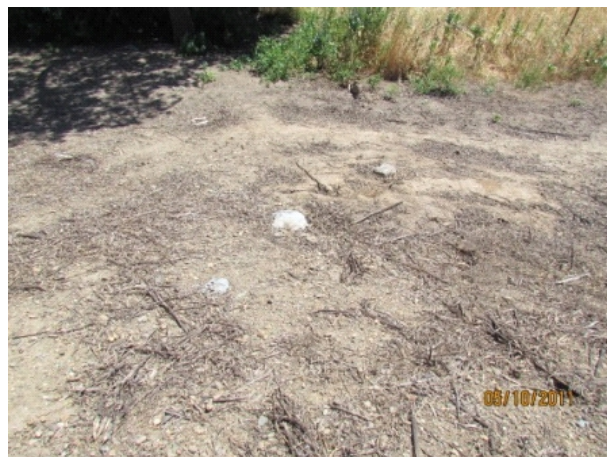
Levee Mile Report Line	104
Start Levee Mile	18.83
End Levee Mile	18.83
Location	Land Side
Category	Earthen Levee
Item	Animal Control

Rodent holes were grouted by the LMA. The picture was taken from the crown looking downstream.

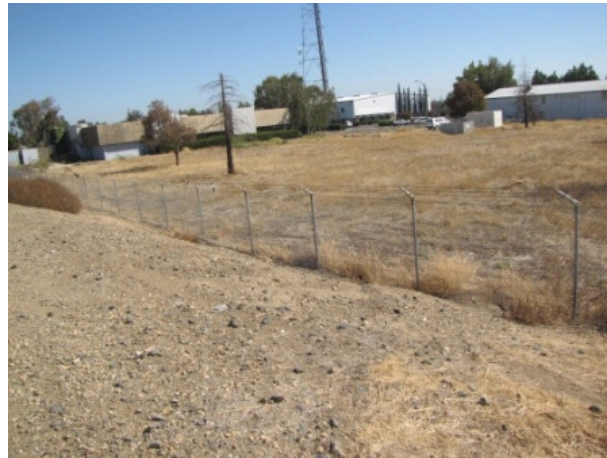
View of a fence along the landward toe looking upstream.

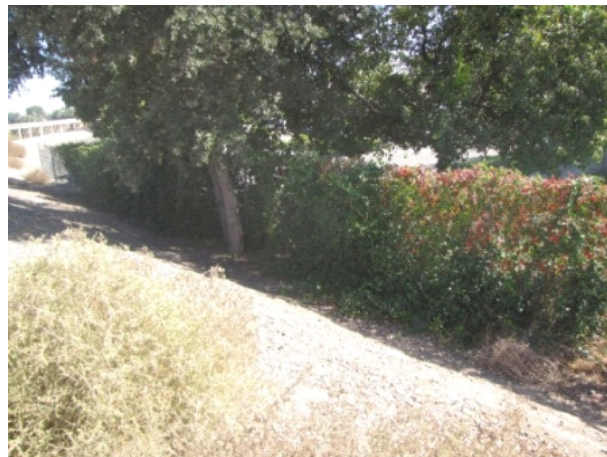
Levee Mile Report Line	108
Start Levee Mile	19.12
End Levee Mile	19.14
Location	Land Side
Category	Earthen Levee
Item	Encroachments

View of landscaping along the landward toe.

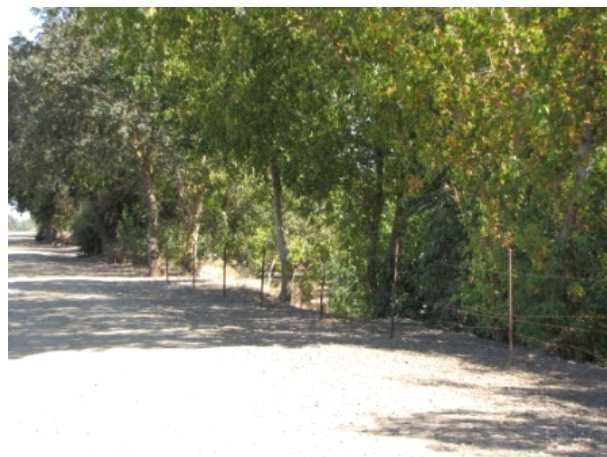
Levee Mile Report Line	115
Start Levee Mile	19.47
End Levee Mile	19.60
Location	Land Side
Category	Earthen Levee
Item	Encroachments

View of a barbed wire fence and landscaping along the landward shoulder and slope looking upstream.

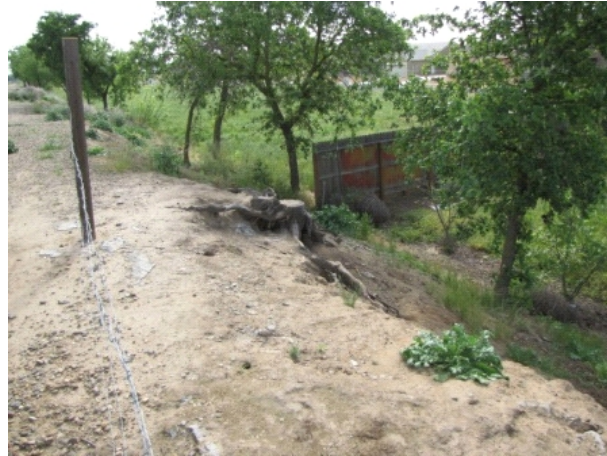
View of a stump on the landward slope looking upstream.

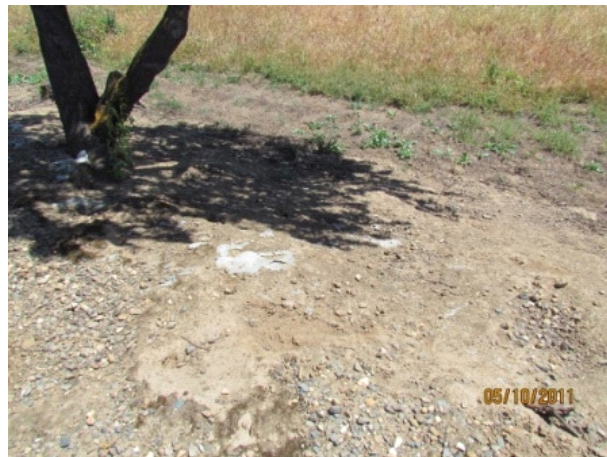
Levee Mile Report Line	118
Start Levee Mile	19.48
End Levee Mile	19.48
Location	Land Side
Category	Earthen Levee
Item	Animal Control

The rodent holes were grouted by the LMA. The picture was taken from the crown looking upstream.

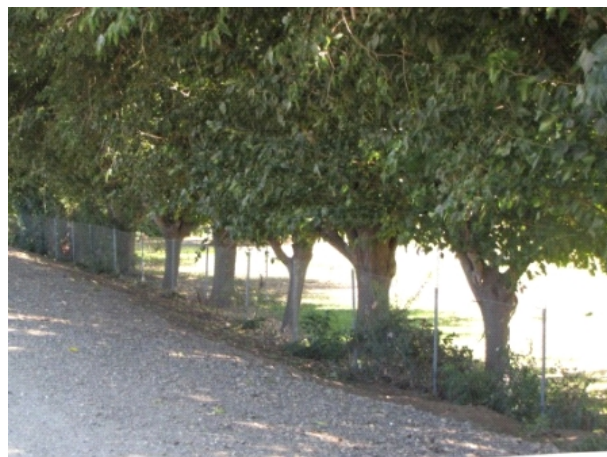
Levee Mile Report Line	120
Start Levee Mile	19.60
End Levee Mile	19.69
Location	Land Side
Category	Earthen Levee
Item	Encroachments

View of a fence along the landward slope looking upstream.

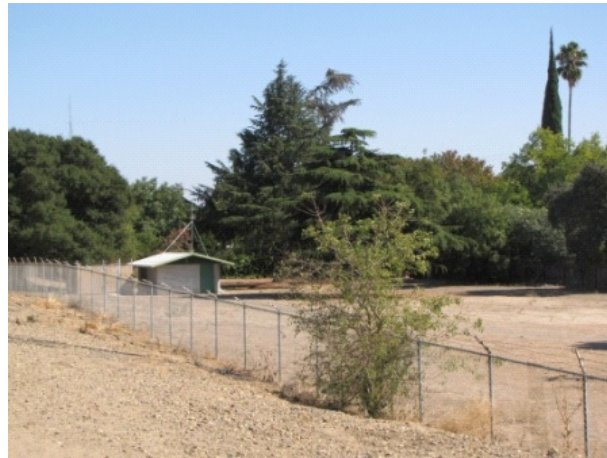
View of a fence along the landward toe looking upstream.

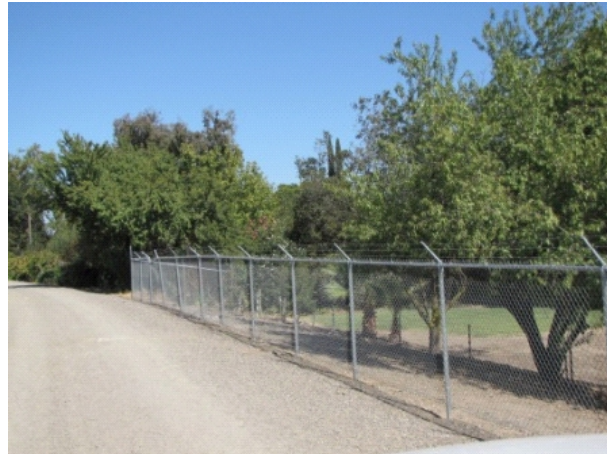
Levee Mile Report Line	141
Start Levee Mile	20.26
End Levee Mile	20.28
Location	Land Side
Category	Earthen Levee
Item	Encroachments

View of a fence along the landward slope looking upstream.

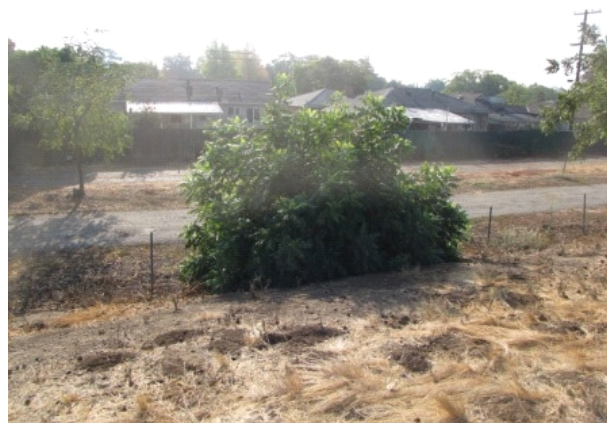
Levee Mile Report Line	142
Start Levee Mile	20.32
End Levee Mile	20.32
Location	Land Side
Category	Earthen Levee
Item	Trim / Thin Trees

View of a tree blocking visibility and access along the landward slope looking landward and downstream.

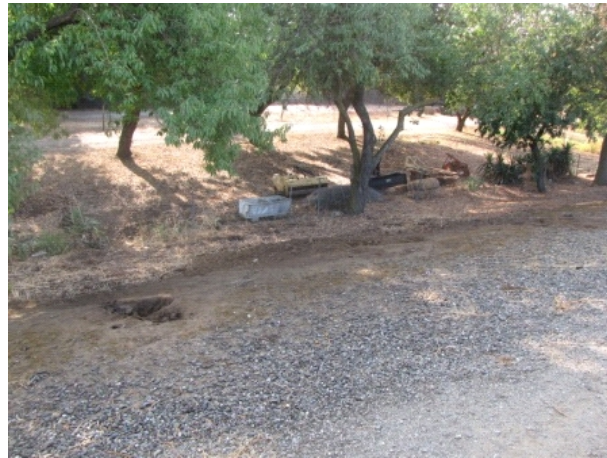
View of rodent activity on the landward slope looking landward and downstream.

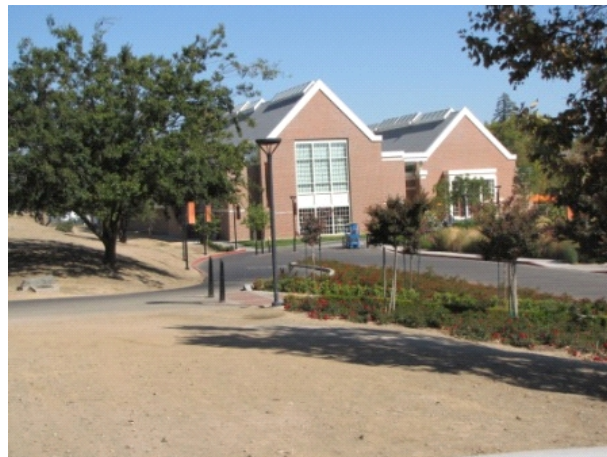
Levee Mile Report Line	145
Start Levee Mile	20.83
End Levee Mile	20.83
Location	Land Side
Category	Earthen Levee
Item	Encroachments

View of landscaping planted and maintained by UOP along the landward slope and toe looking upstream.

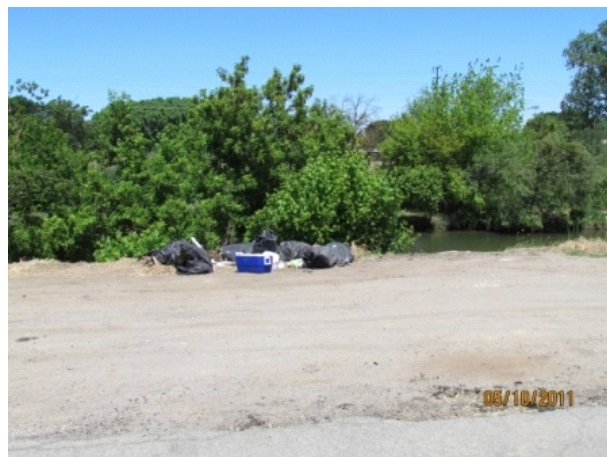
Levee Mile Report Line	151
Start Levee Mile	21.63
End Levee Mile	21.63
Location	Water Side
Category	Earthen Levee
Item	Encroachments

Garbage was found on the waterside of the levee. The picture was taken from the crown looking upstream.

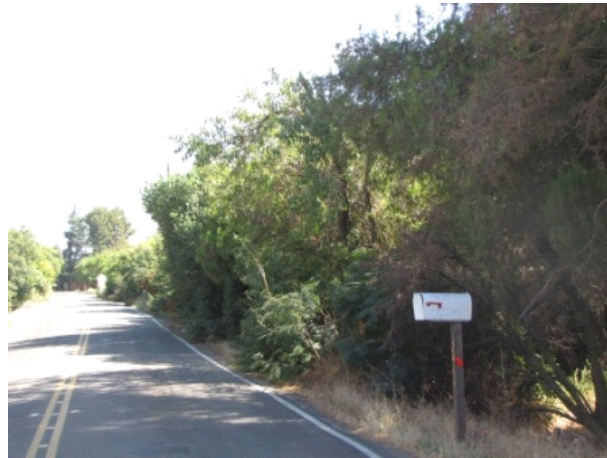
View of landscaping along landward slope looking upstream.
